Corbin 39 : Repairing Damage To Keels, Skegs, And Rudders

#135 "Petit Chantier" previously "Necessity"

#086, “Stella”, previously “Jack Iron”

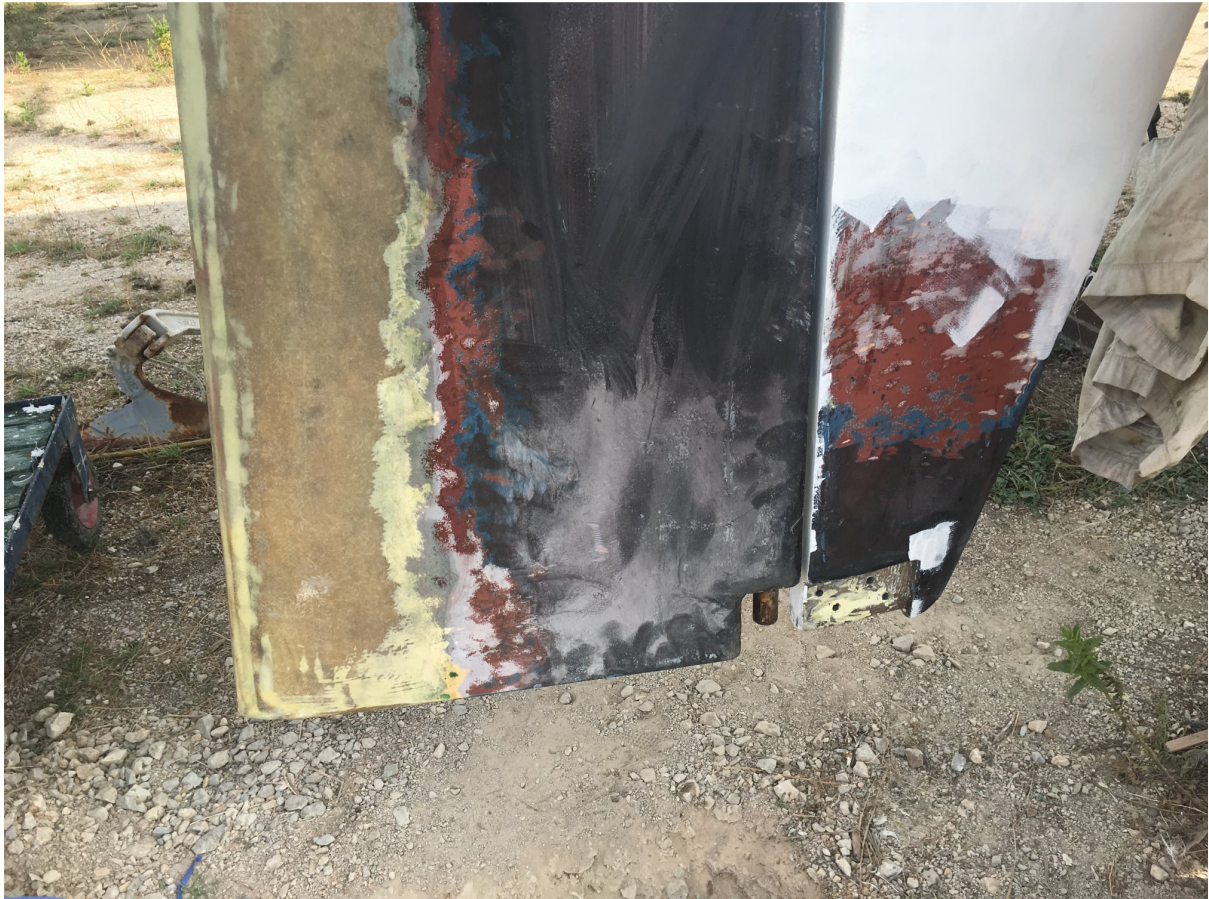
1. The backside of the skeg, looking towards the bow, after our initial grinding. We marked all the holes and bored everything out.
2. The heel shoe, with the bronze bolts removed, before repairs.

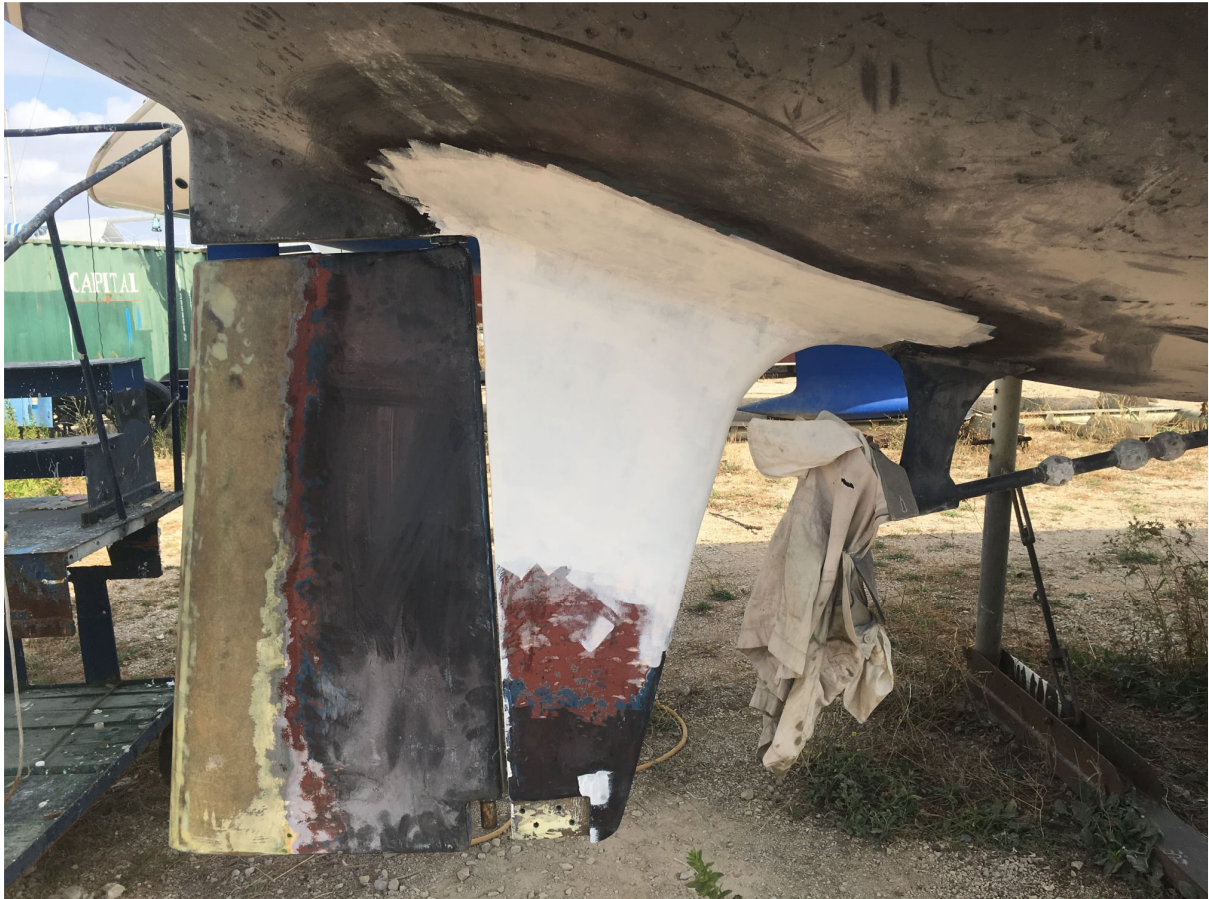
3. The backside of the rudder and skeg, before repairs after initial grinding.
4. One of the four bronze bolts holding the shoe in place.
5. Frontside of the skeg, looking towards the rear, after initial grinding. We marked all the filled in holes and proceeded with grinding everything out.

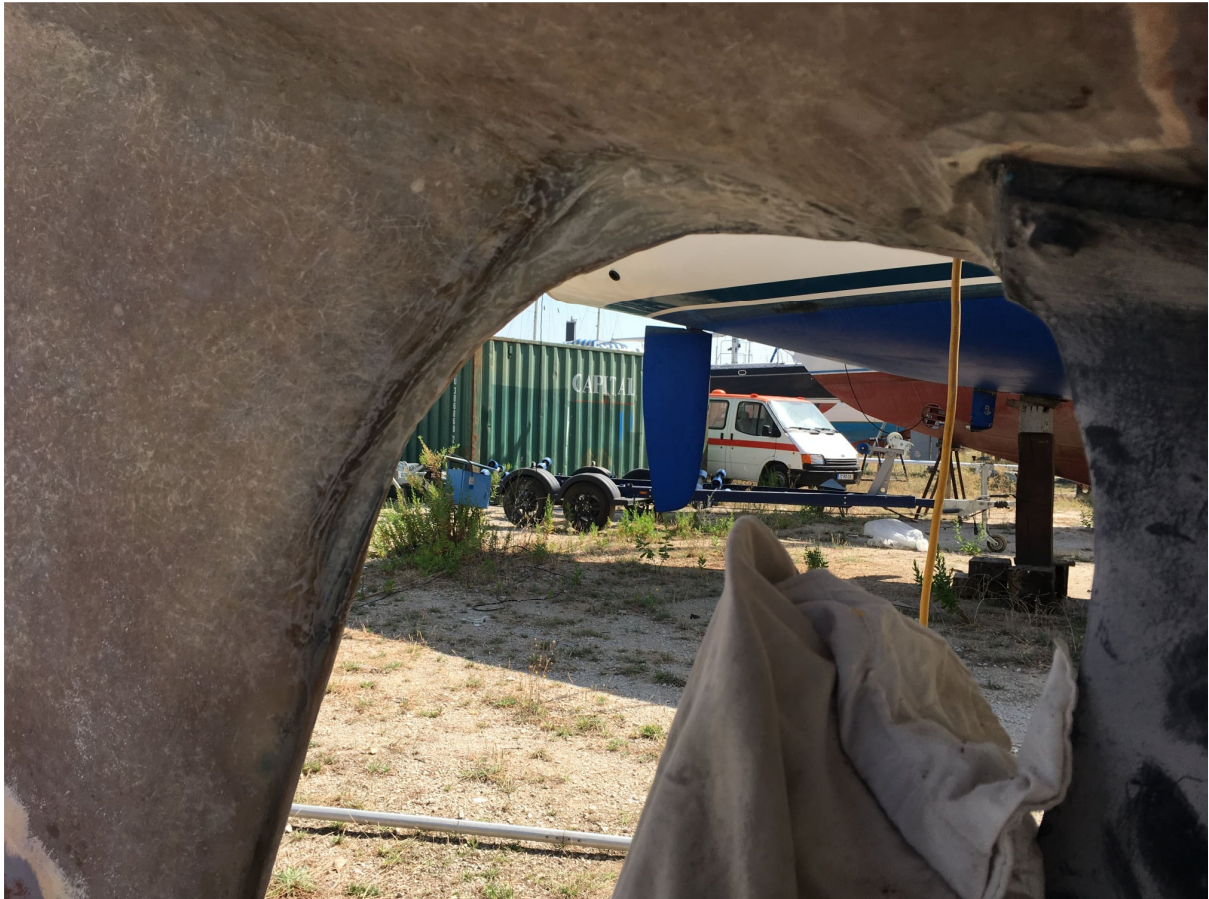
6. Another photo looking at the skeg towards the rear, with a bit of the prop in the bottom right corner. All the old repairs had to be removed.
7. Surface crazing of the rudder and skeg. We were not worried about this.

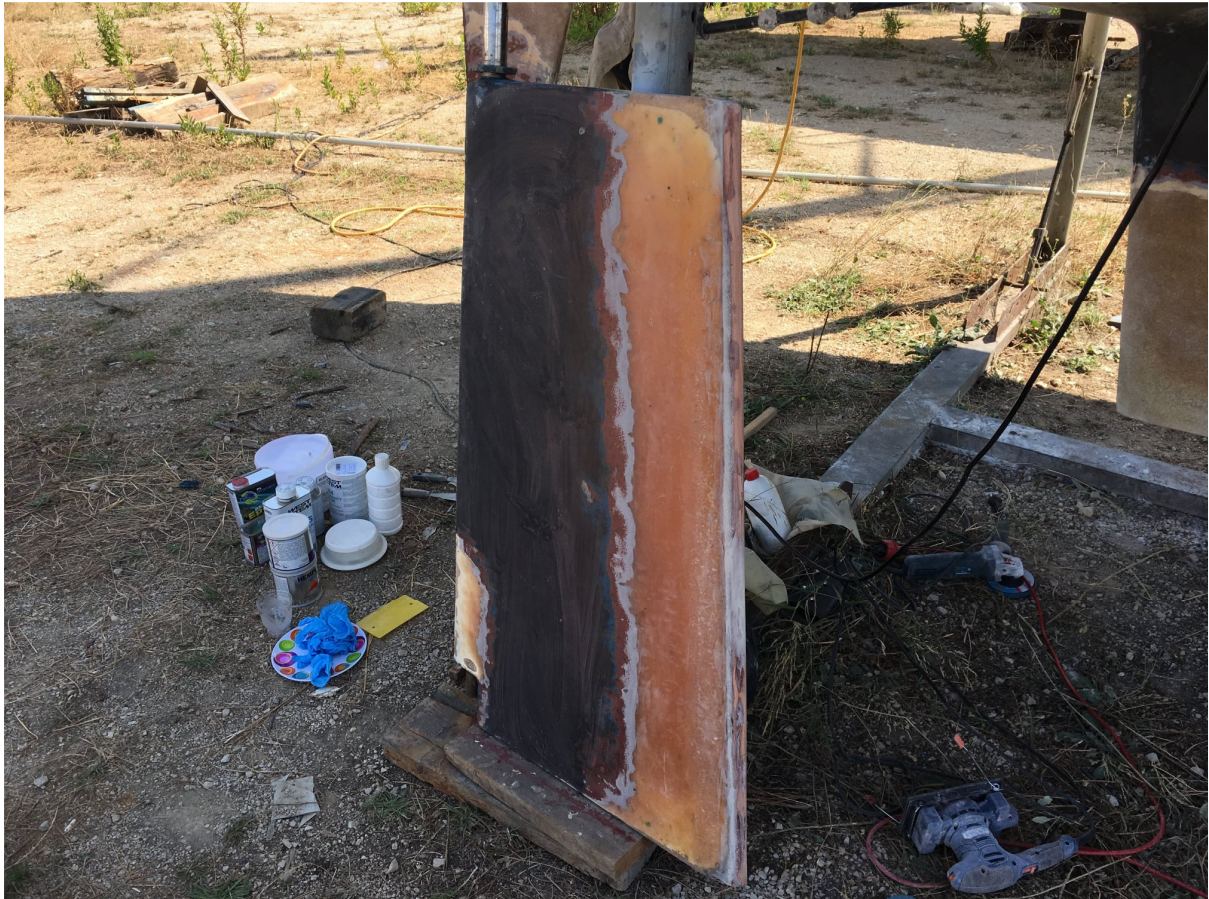
8. Front of the skeg after initial grind. You can see how the old polyester filament had not stuck properly to the fiberglass and broke apart.
9. Rudder, looking at the backside with the wooden profile taken off.

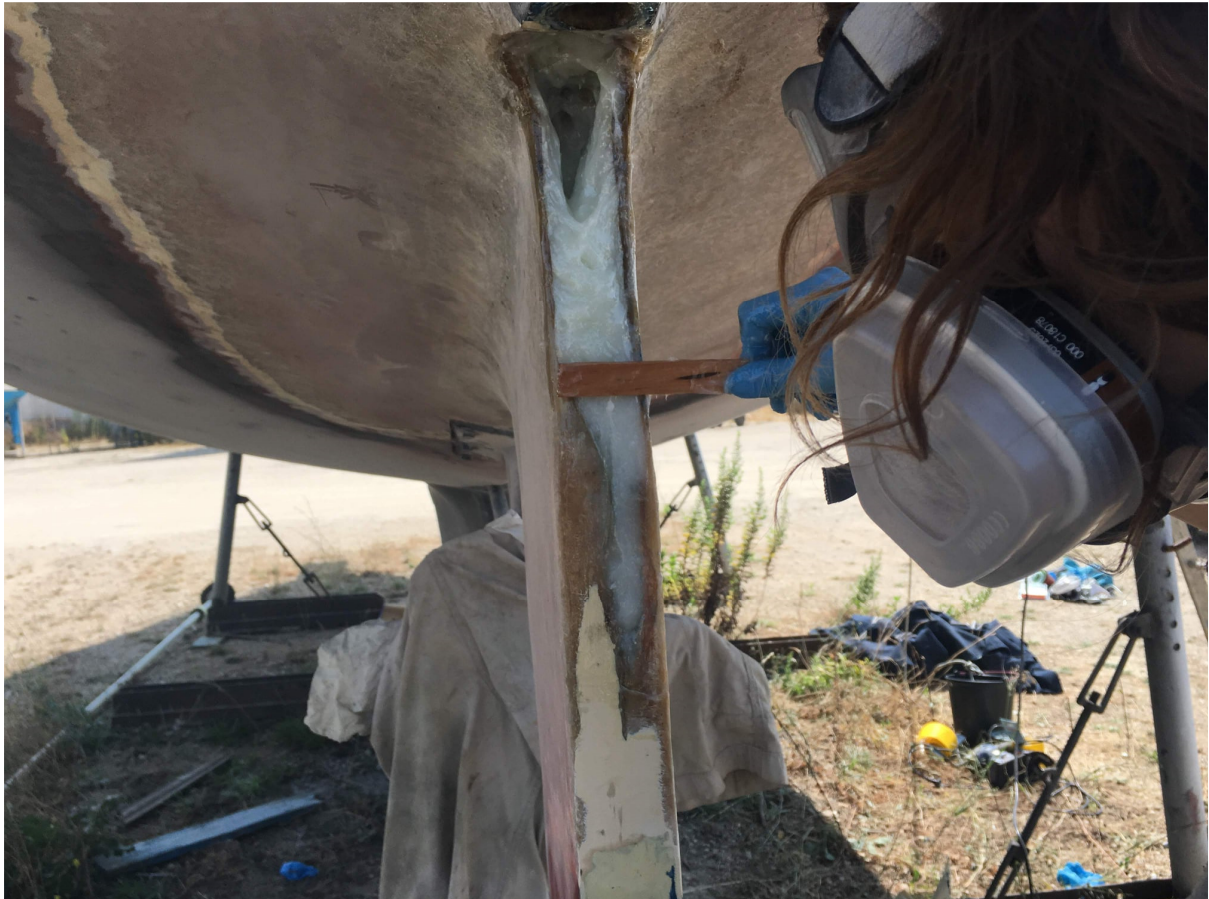
We didn't do anything about the crack in the rudder shaft. Although this was a giveaway that the rudder was maybe overpowered or had hit something, repairing it meant rebuilding entire parts of the hull and rudder assembly, and we judged that the damage was just not big enough to justify it.

10. Some more grinding and sanding around the stern and bottom of the boat, so we could apply fiberglass cloth later.
11. The crack in the fiberglass rudder shaft, looking upwards into the shaft. We did nothing about this crack, as we judged the cost of the repair being higher than the proceeds.

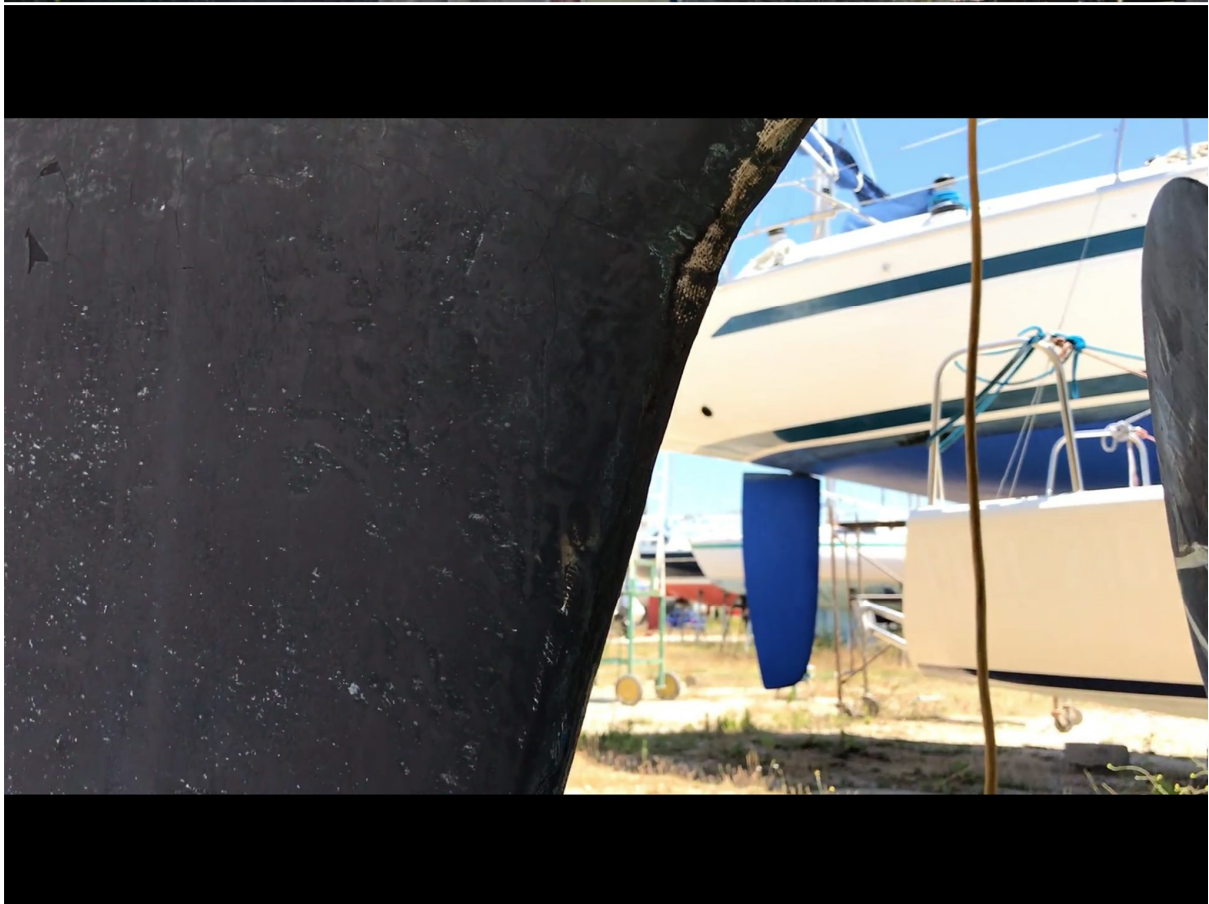
12. The rudder, frontside, with the beginning of a crack at the split where the two sides of the mould would have been glued together. We sanded and grinded down the crack, faired it with epoxy and reinforced it with fiberglass cloth, cut to size.

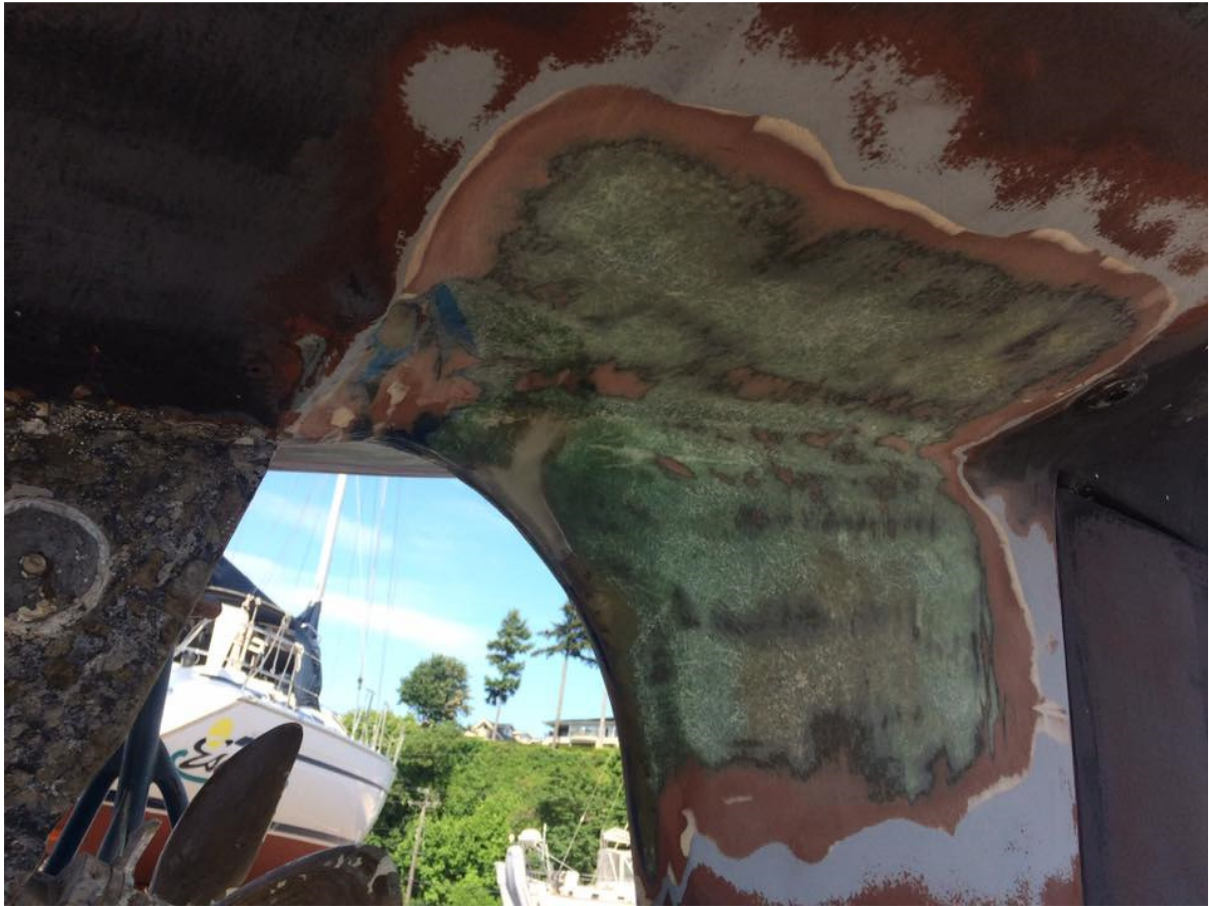
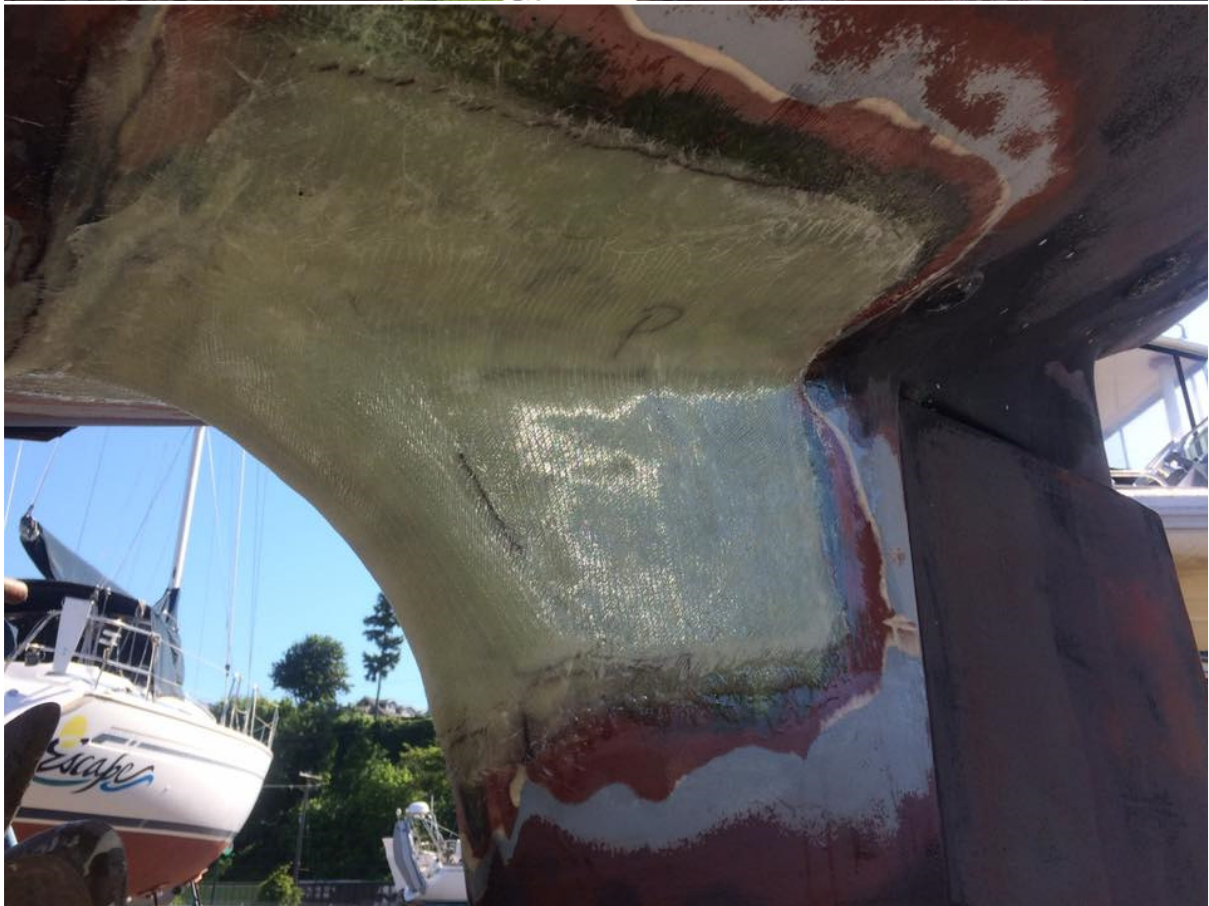
During the course of these projects Bill Schmid informed us that a few years ago he had suffered skeg damage from impacting a large log in British Columbia. He fixed it with an external fibreglass repair as shown in these photos.
